BORING MILL GEAR EXAMINED FOR METALLURGICAL DEFECTS

Technical Note No. WAL TN 201/1

E. L. Reed

December 1959

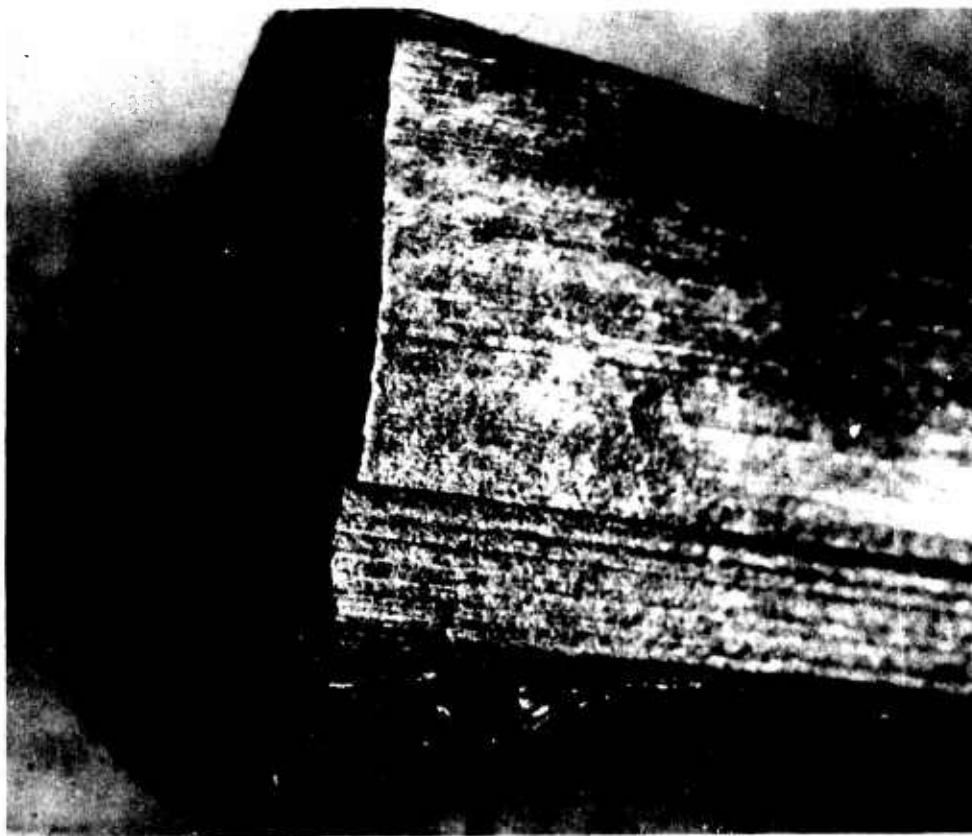
FIGURE 1

A noticeable machine mark or undercut was present where the root circle joins the flank of the tooth. Such a condition is a stress riser when the gear is subject to shock. Figure 1 illustrates the undercut which caused the failure of the tooth.

Undercutting at the base of one of the gear teeth is responsible for rupture of the tooth.

BROKEN TOOTH AT "A" SHOWN IN FIGURE 2. DEEP UNDERCUT IS SHOWN WHERE
ROOT CIRCLE JOINS FACE FLANK OF TOOTH. NOTE ARROW SHOWING ORIGIN OF
FAILURE.

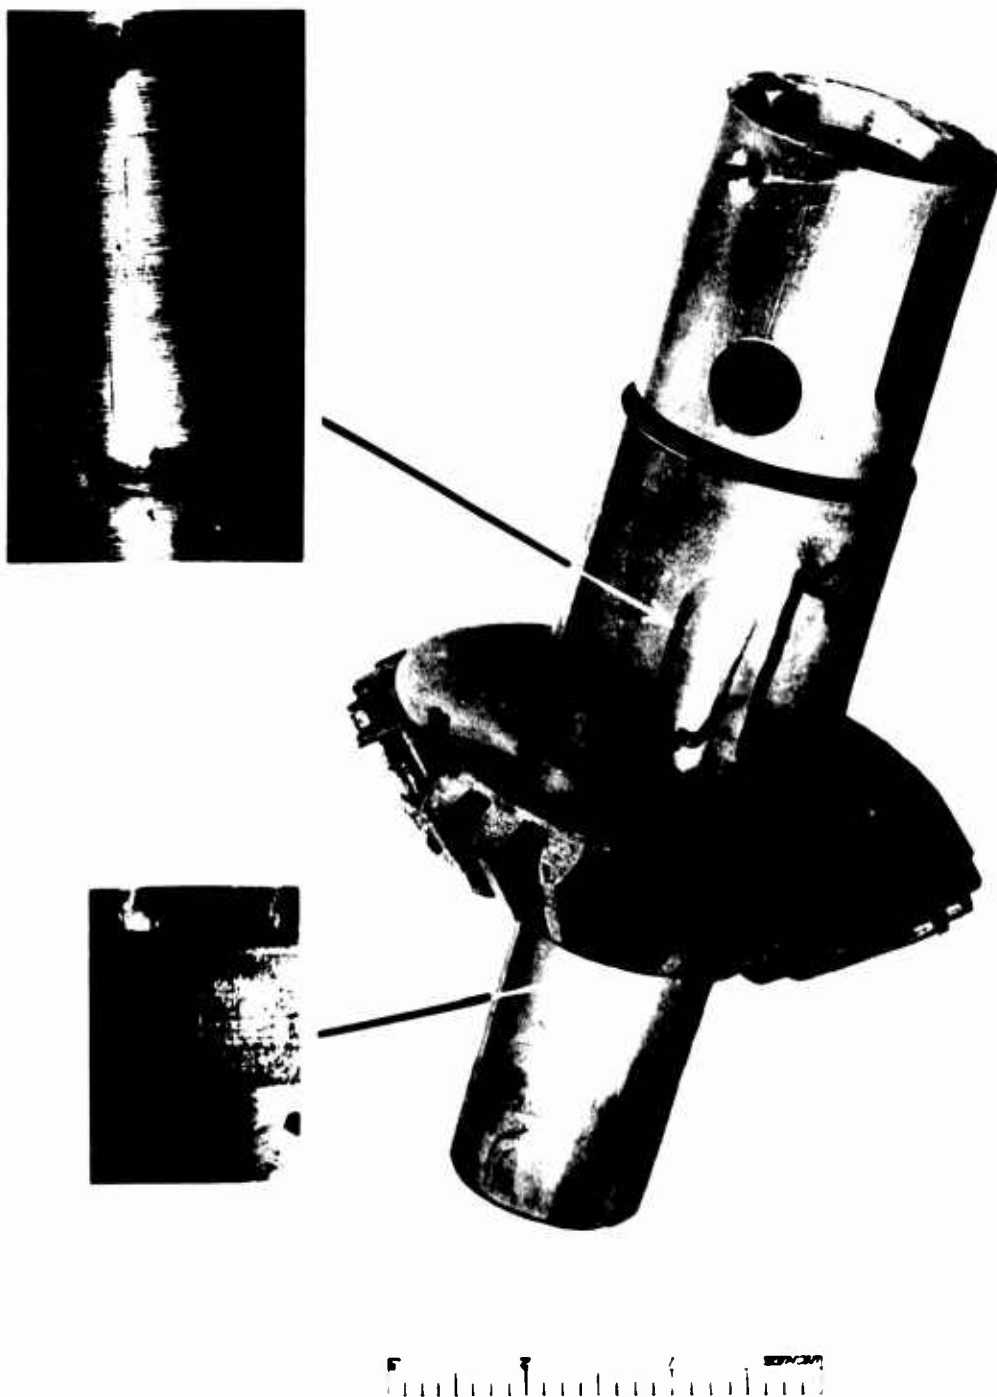
The section was subjected to the Zyglo penetrant test. It was found that the shaft contained many seams and fine longitudinal hairline cracks (Figure 2). No such cracks were found in the gear.

Since the boring mill gear contained pronounced segregations of non-metallic inclusions and porosity, it is believed the section was machined from a central portion of dirty barstock. Undoubtedly, the fine hairline cracks found on the surface of the shaft are connected with the elongated nonmetallic stringers present in the steel.

DEFECTIVE 3" HORIZONTAL BORING MILL G&L GEAR, WA 3351. TWO TEETH ARE MISSING ON THE GEAR (SEE "A" AND "B"). TYPICAL FINE LONGITUDINAL CRACKS ON THE SHAFT ARE REVEALED BY ZYGLO PENETRANT TEST.

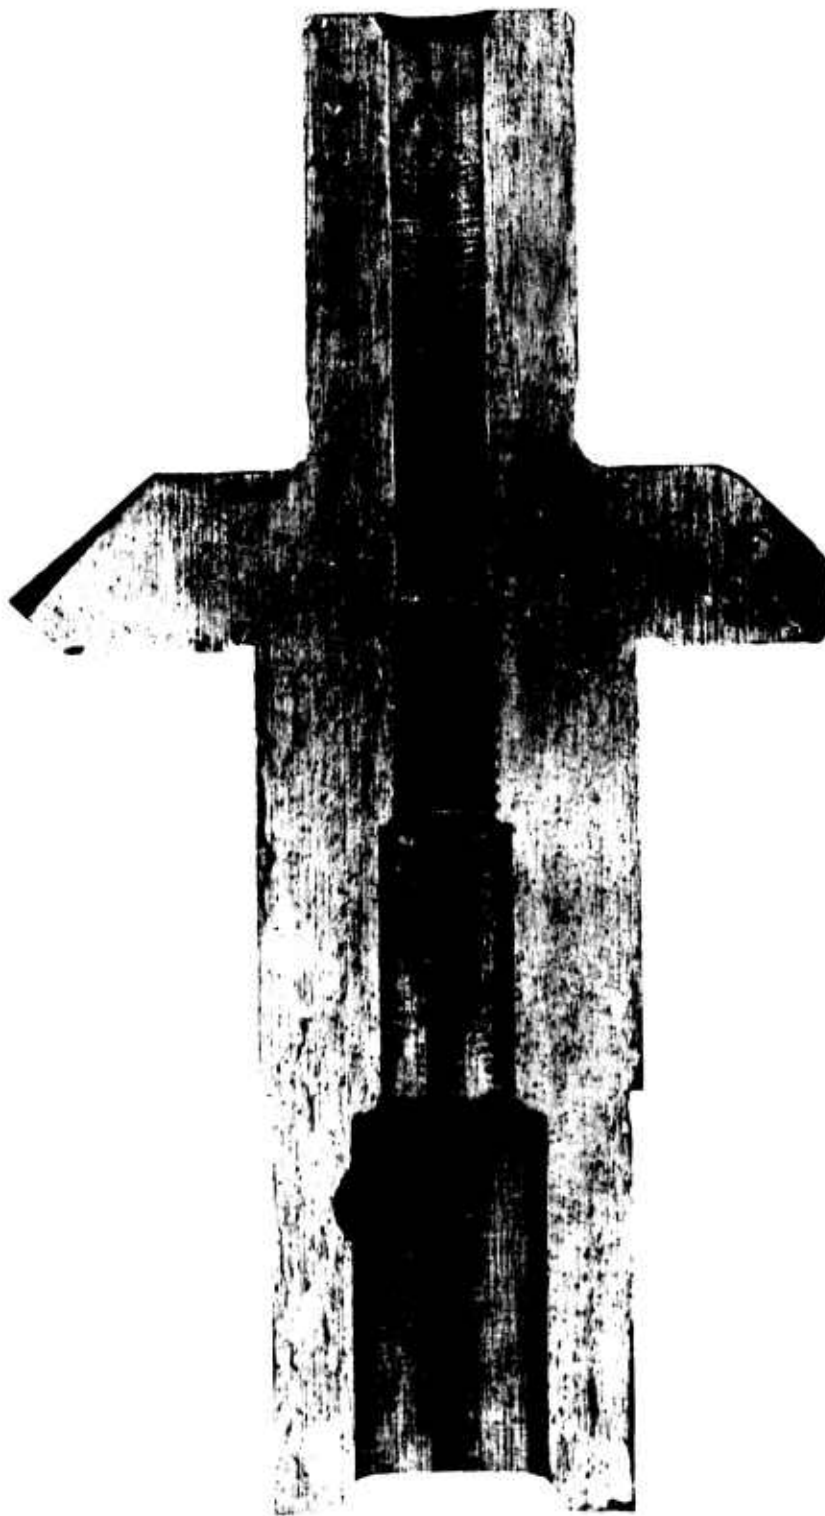
The section was cut through the longitudinal axis, blanchard ground and etched in a macro-etching solution containing 38% hydrochloric acid, 12% sulphuric acid, and 50% water heated to a temperature of 170°F. The macrostructure consists of banding or straight-grained structure, sometimes called fiber, which is typical of that found in sections machined from barstock (Figure 3).

In the gear section examined which was machined from barstock, the fiber produces a straight-grained structure. When fiber is parallel to the pitch line of the tooth and parallel to the direction of applied stress, this tooth will be greatly inferior to a properly forged upset gear section where the grain of steel flows radially and the direction of applied stress is perpendicular to the direction of fiber.

MACROSTRUCTURE OF LONGITUDINAL SECTION OF GEAR AND SHAFT. THIS SECTION WAS IMPROPERLY MADE AS IT WAS MACHINED FROM BARSTOCK RESULTING IN AN UNSATISFACTORY DISTRIBUTION OF FIBER, THAT IS, A STRAIGHT-GRAINED STRUCTURE. SECTION IS CUT THROUGH THE BASE OF BROKEN TOOTH "A" (FIGURE 2).

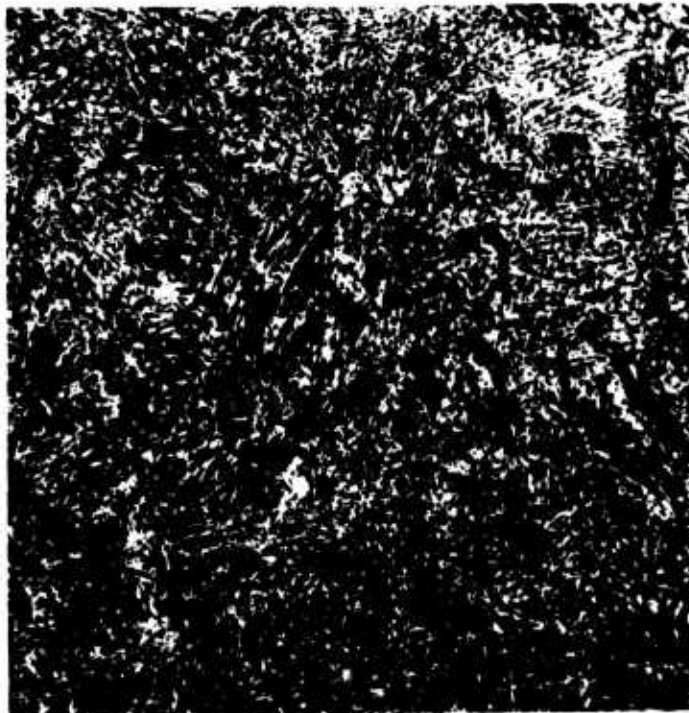
The heat treatment given the section was not adequate to obtain a desirable microstructure of tempered martensite.

PICRAL ETCH
X1000
TYPICAL SLACK QUENCHED STRUCTURE OF BROKEN TOOTH
F - FERRITE,
B - TEMPERED HIGH TEMPERATURE BAINITE,
M - TEMPERED MARTENSITE
